**PARMELEE FARMHOUSE**  
**Killingworth, Connecticut**

**HISTORIC FABRIC ASSESSMENT SURVEY**

**Prepared for**  
**The Town of Killingworth**

**January 2011**

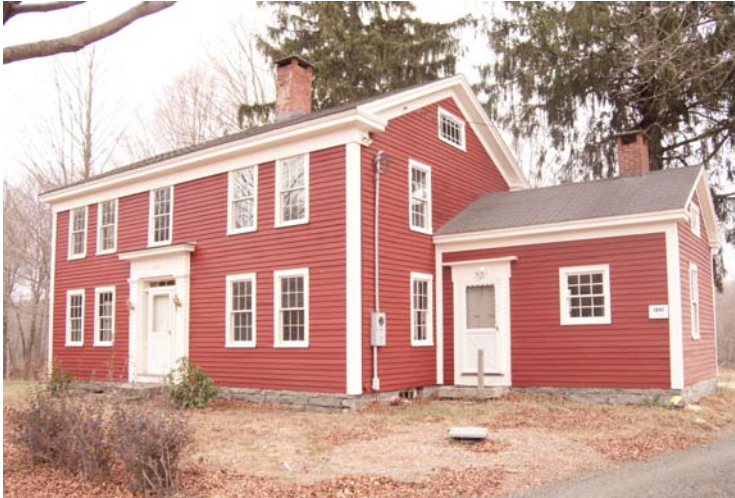
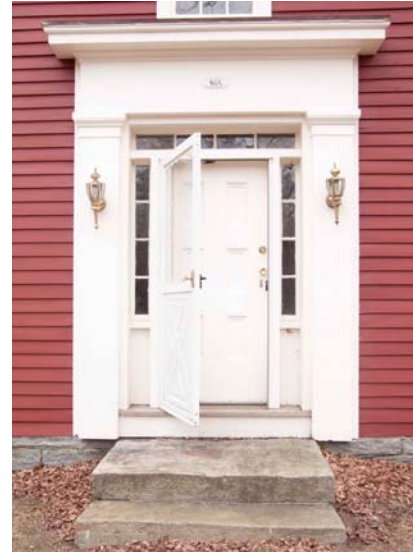
Siding consists of sawn, tapered clapboards applied with uniform exposure. Stylistically the building is quite simple; ornamentation is limited to the front entry way, cornices, and gable window sash. These elements are fabricated and arranged in a pattern found on Greek revival buildings constructed beginning in the 1830s. On the Parmelee House the

ornamentation is of an applied nature. The proportions and orientation of the building are similar to buildings constructed during the Georgian and Federal period. The Greek style is only represented by the building's mildly elliptical exterior moldings, entry way surrounds, door panel configuration, and friezes.

**Left, Exterior of the Parmelee House looking northeast. Right, Front Entry**

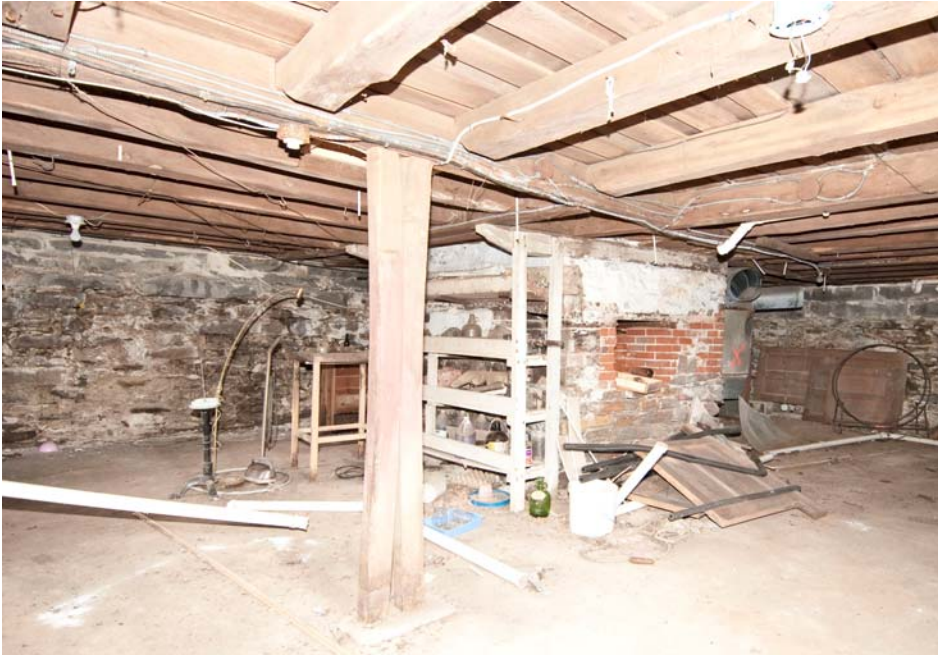
**Basement looking northwest**

Most of the original framing, foundation, and chimney stack is still visible in the basement. The chimney base is of particular interest; on its north side the remains of a basement kitchen fireplace survive. Although basement kitchens are found in buildings of this period throughout Connecticut, they are by no means common. The location of this

fireplace and its relationship to the kitchen wing could suggest a more complicated food processing regiment possibly relating to a divided household or variations in seasonal activities.

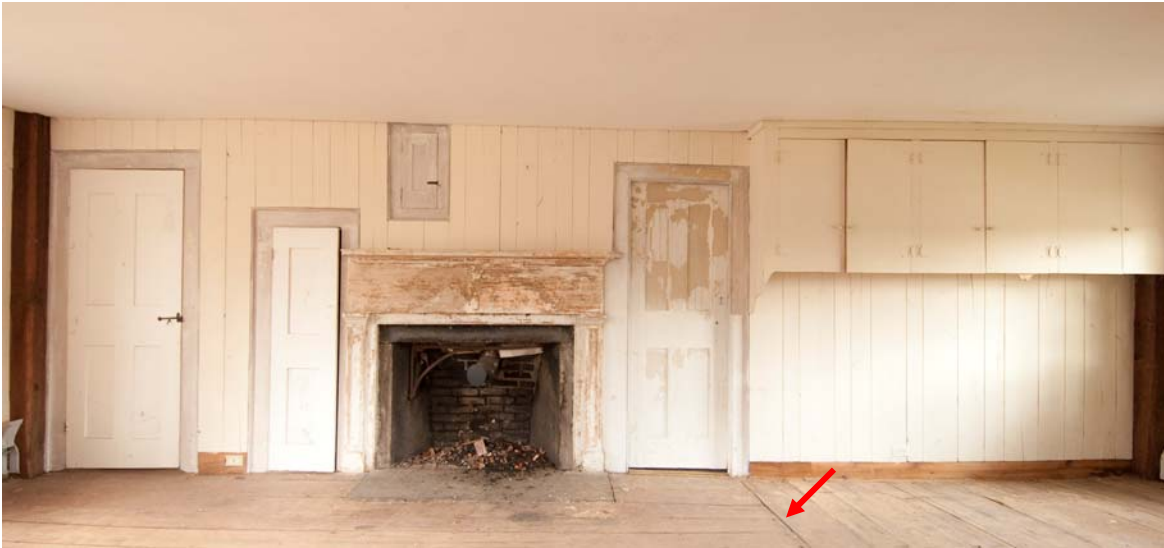
Presently this room extends from the front to the rear wall of the structure. Seams visible in the flooring along with anomalies in paint stratigraphy of the room's trim indicate this space was once divided into two rooms. The front room contained was heated with a fireplace with wrought iron crane. The rear room was more utilitarian in function; the stairway and the rear exterior door allowed for direct communication with the farmyard, the cellar, kitchen, and storage in the garret of the main block and kitchen wing.

**South room, north wall, arrow indicates location of earlier partition**

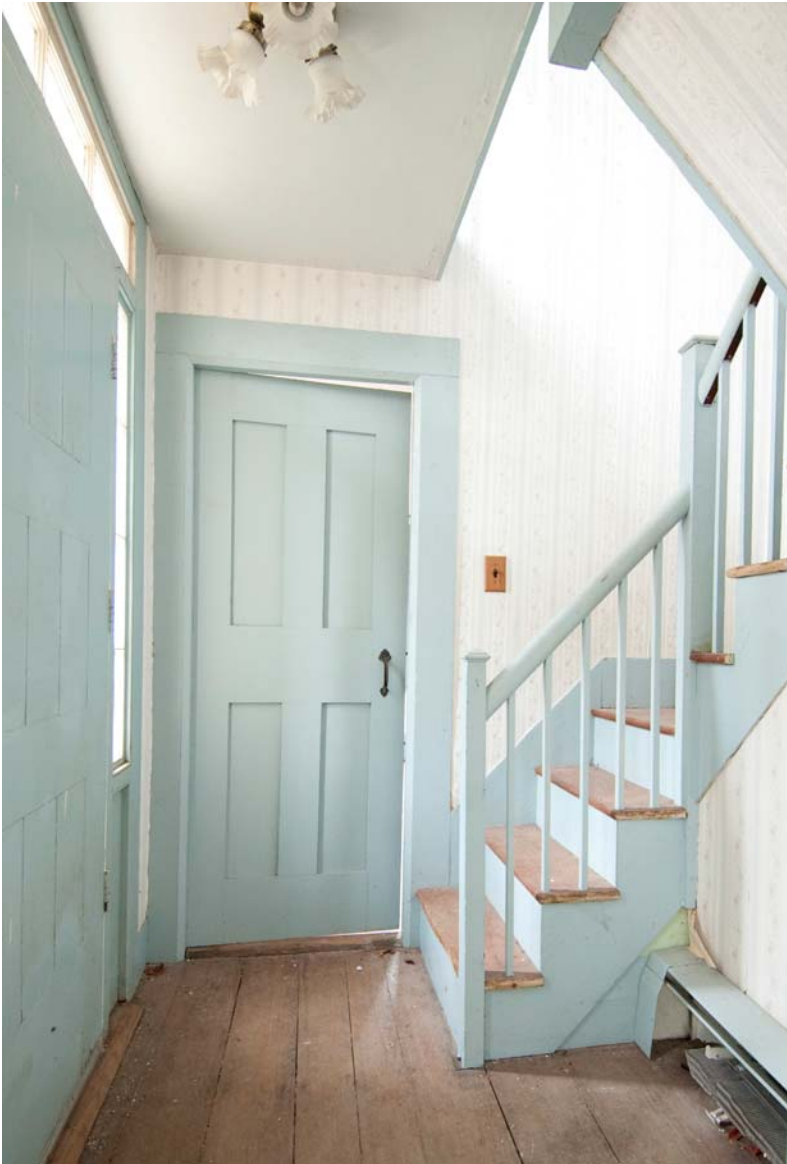
**Entry looking north**

Interesting features in the entryway include the beveled fascias surrounding the doorways and the flush panels of the entry door. Door latches in the entryway are Blake's latches patented in 1840. These latches are used throughout the structure and represent the rapid introduction of cheaper mass produced hardware available during this period. Most of the

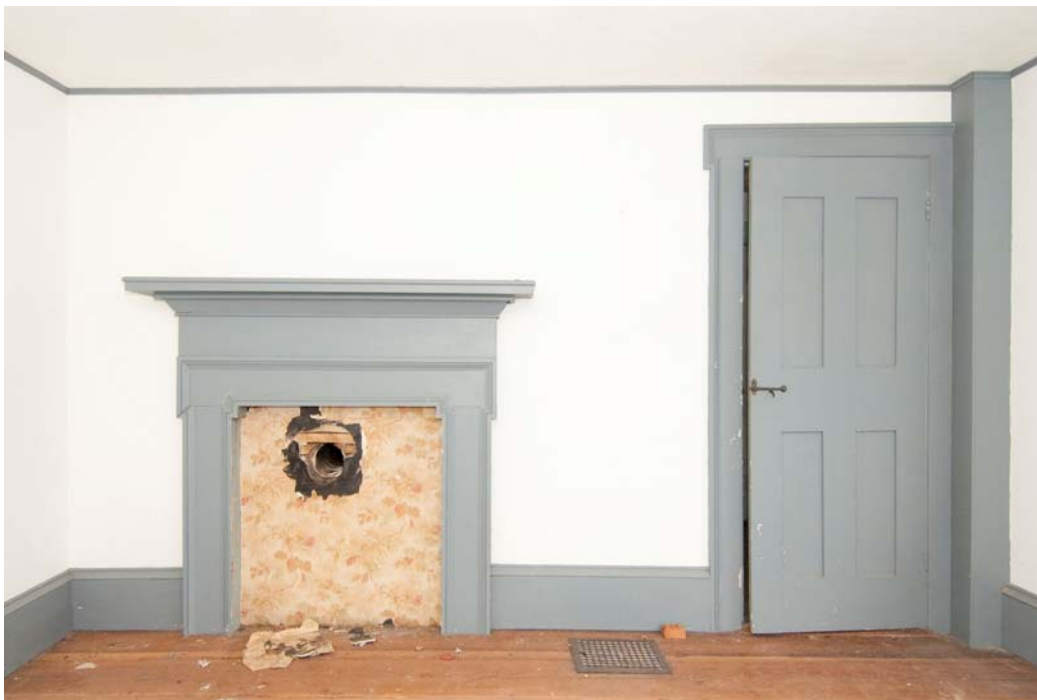
North parlor, south wall

Originally this was the best room in the house and it exhibits the most sophisticated trim found within the structure. The doors, windows, and mantel support facias have extended head casings (crossette). Unlike the trim found in the other rooms of the structure the door, window mantel architrave and baseboards have fully developed Grecian ovolo band moldings applied to them.

The presence of accordion lath, plaster, and lack of masonry hearth indicates this room was built originally without a fireplace. The mantel was placed in the traditional location; however, its purpose was strictly ornamental. Originally a stove was located in front of the mantel and surround and vented through the surviving thimble. This is another indicator that this parlor was the best room in the building. Although stoves had been available for decades, in rural areas they would have been considered modern innovations.

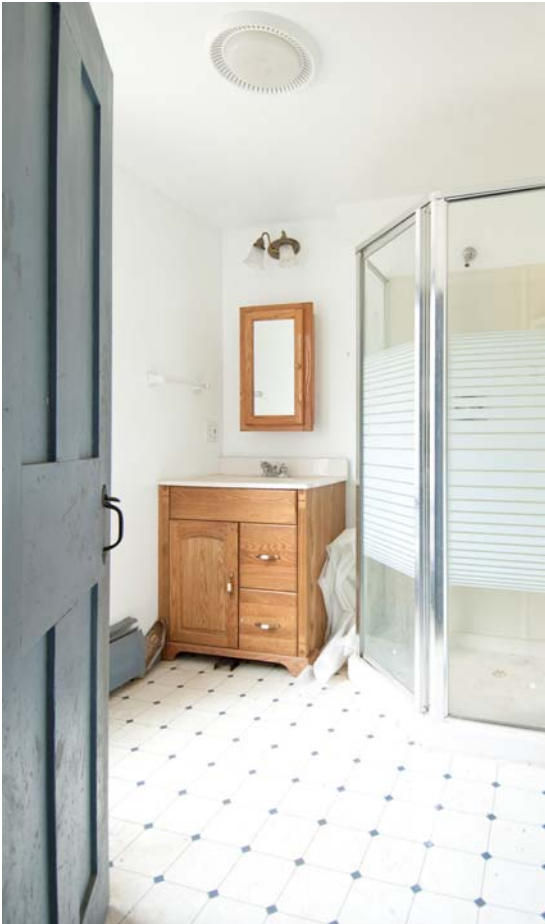
**Northeast bathroom**

This space contains very little original fabric and was converted into a bathroom and laundry room. Surviving fabric is limited to the doors accessing adjacent rooms.

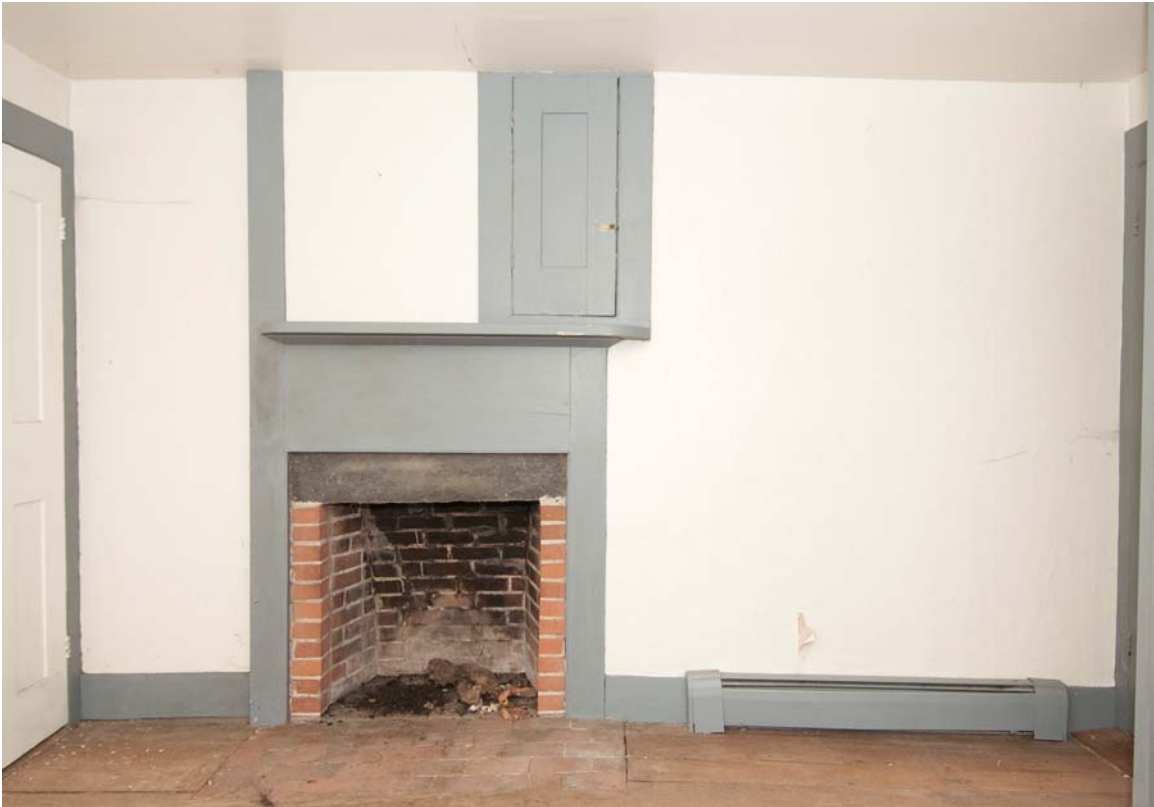
**East central room, west wall**

The room directly behind the chimney stack was possibly used as a bedroom during the Parmelee's tenure. Unlike the second floor chambers it was originally heated and contains a small fireplace with hearth. The trim in this room is simple; it is not ornamented and except for the mantel shelves' support no molding is found. Modern shelving has been installed along the north wall otherwise the majority of the space's architectural fabric is contemporary with the original construction of the homestead.

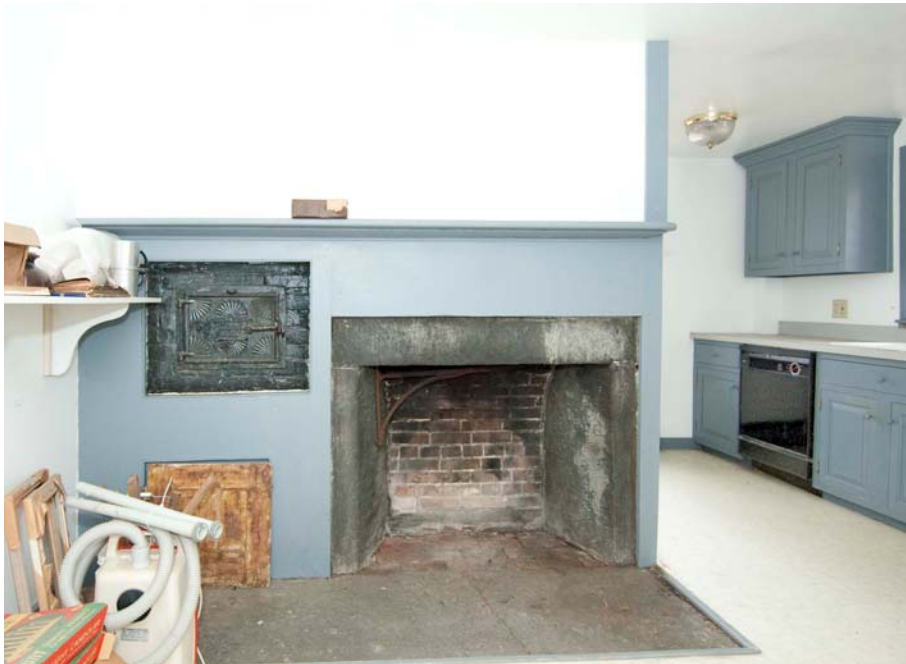
**Fireplace and bake oven, kitchen wing**

Although not common in Connecticut the practice of locating the kitchen in an attached wing begins to be adopted in parts of rural New England during the 1830s. During the last phase of occupancy the kitchen wing was still used as a kitchen. It contains a modern sink and utilities installed during the last quarter of the 20th century. The space does retain its original kitchen fireplace with external bake oven, hearth, stone fireplace jambs, lintel, and bake oven door. Based on a cursory inspection of the paint stratigraphy surrounding the fireplace much of the trim has been replaced or modified. The cast-iron

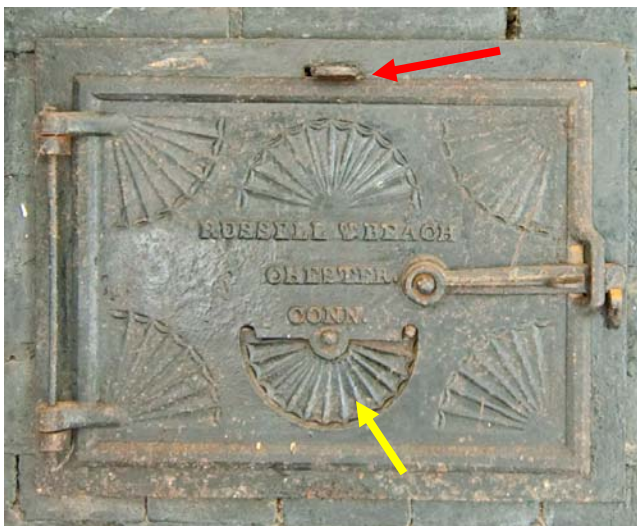
bake oven door is a particularly fine example. This type of fixture was commonly found in buildings constructed during the first decades of the 19th century. It was manufactured by Russell and Beach located in Chester, Connecticut. It exhibits ornamented draft control and an integral damper. Surviving components within the space include:

**Bake oven door manufactured by Russell and Beach, Chester, Connecticut. Damper control (red arrow), draft control (yellow arrow)**

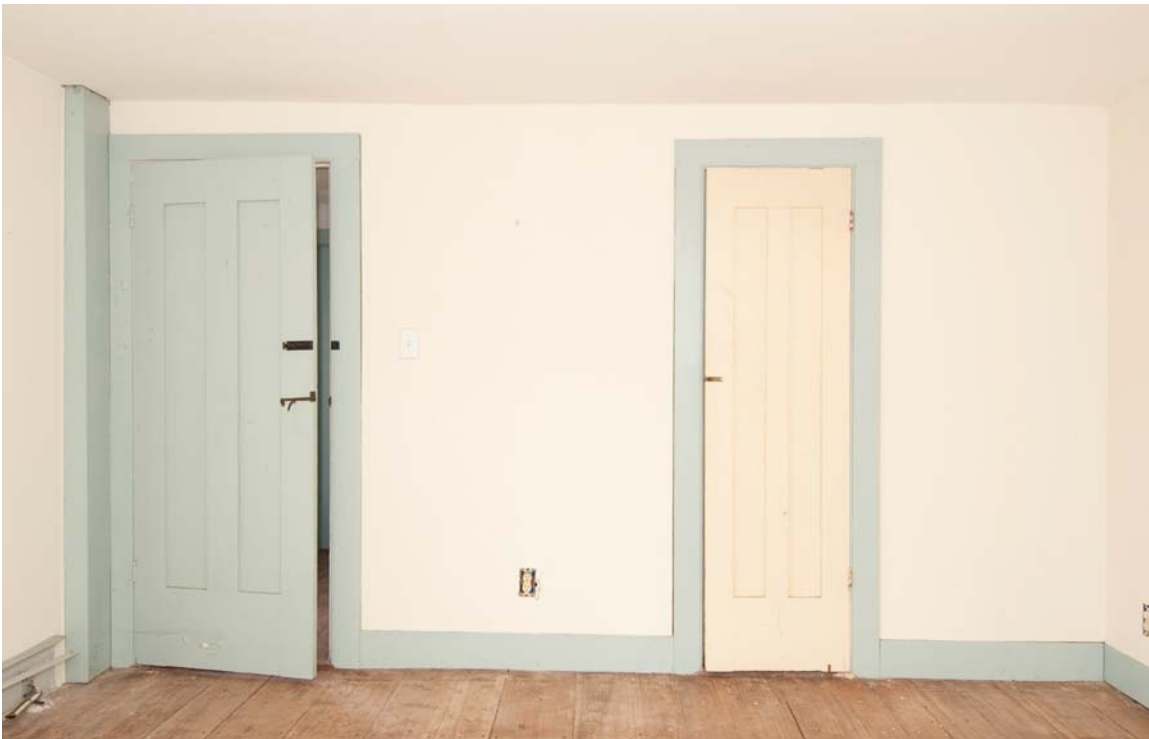
**Southwest chamber, north wall**

Although unheated this space was most probably used originally as a bedroom. A closet is located in the north wall. Most architectural elements within the space are original and include:

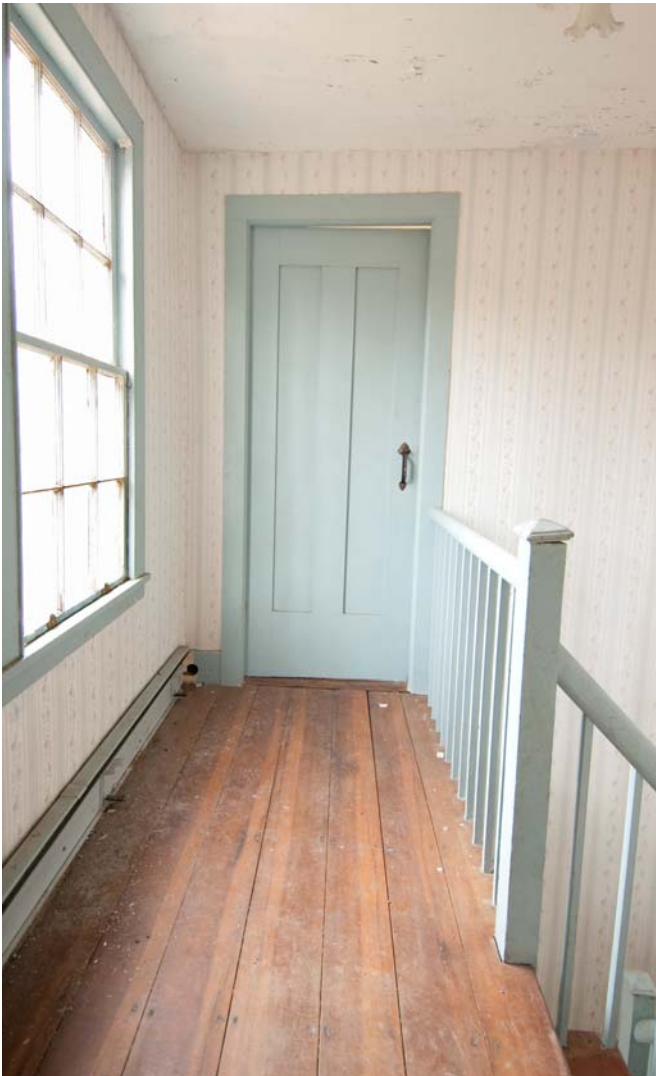
**Stair hall, second floor, looking north**

Trim located in the second floor of the front entryway is similar to the first floor; however because of its separation from the more formal and public rooms some economy is visible in the fabrication of several elements primarily the doors. Unlike the doors found in the entryway and adjacent rooms these doors are two panel as opposed to the four panel doors found in the better spaces of the first floor. An exception to this is the

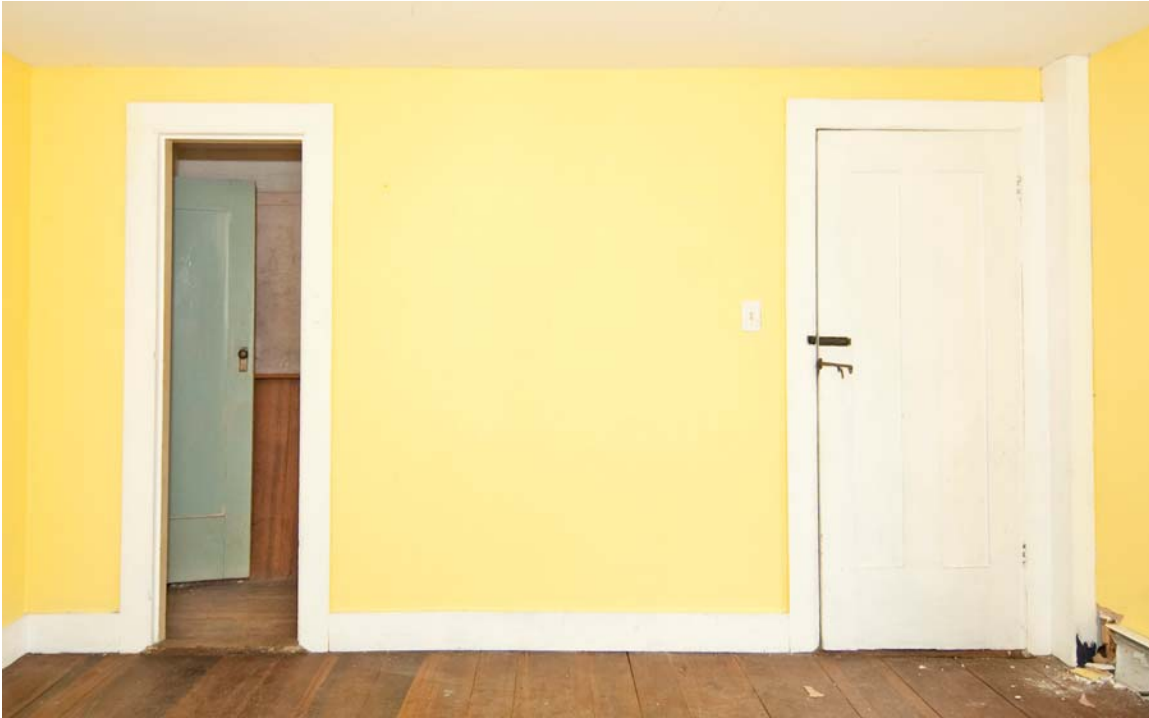
**Northwest chamber, south wall**

Finish in the northwest chamber is similar to that of the southwest chamber. The larger closet that can be accessed from both this room and the rear hallway. Although modified, it appears to be an original feature. Original elements located within the space include:

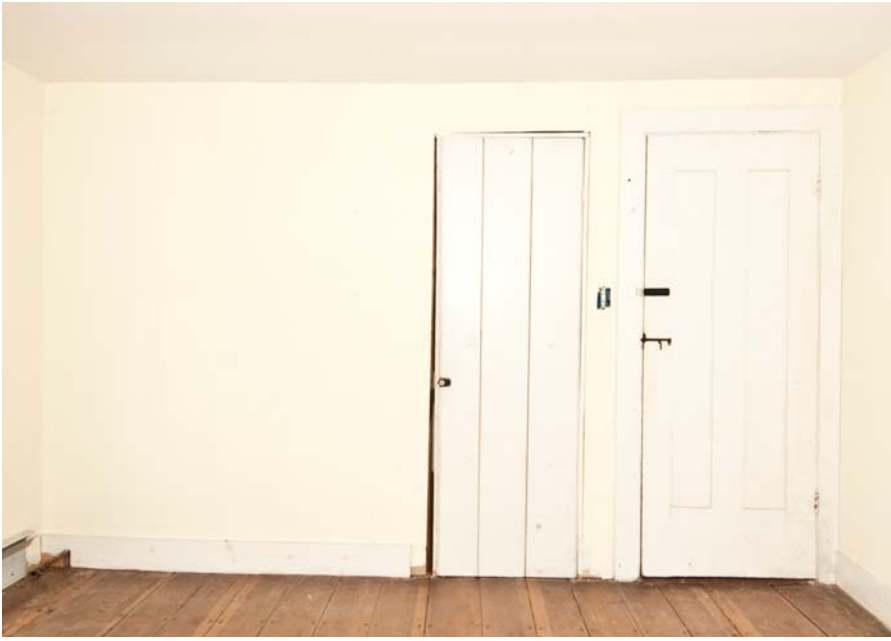
**Northeast chamber, south wall**

This room has undergone more modifications than the adjacent northwest chamber. Sections of the south wall have been rebuilt and it is unclear whether there was originally a closet located on the wall. The sash is modern along with sections of baseboard.

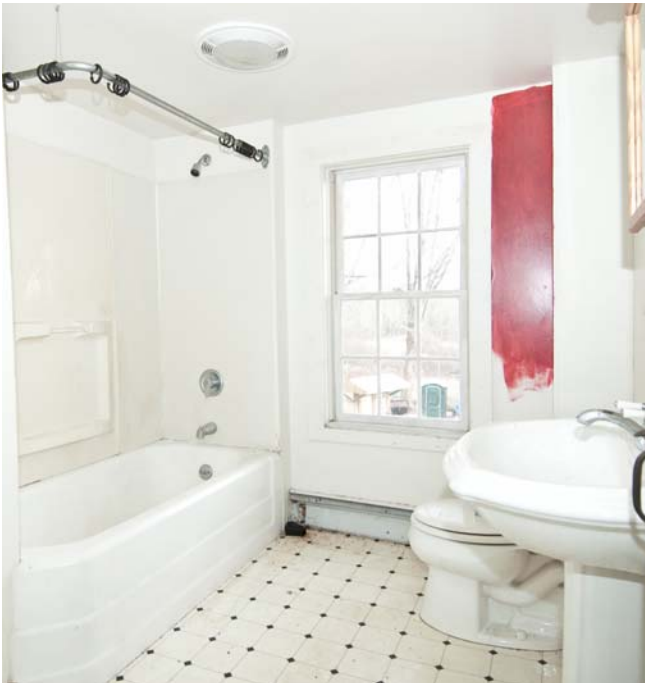
**Rear central bathroom, looking northeast**

This bathroom dates to the second half of the 20th century. The only surviving original material appears to be the window sash. It is unclear whether this bathroom was installed within the footprint of an earlier room.

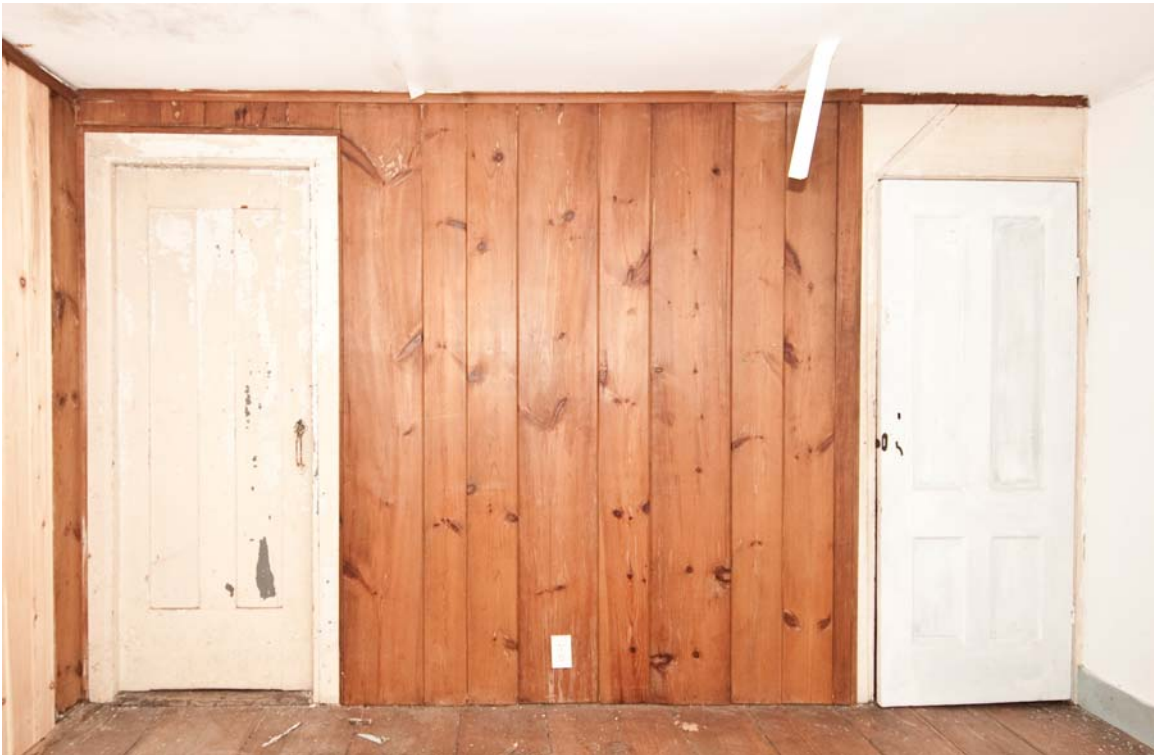
**Southeast chamber, south wall**

This room has also undergone extensive modifications during the 20th century. The area's original plaster work has been covered with vertical, knotty pine boarding. It is unknown if earlier wall finishes survive beneath this treatment. The southeast door used to access the garret stair has been re-hung. This along with a patch at the top of the garret stairs suggest the garret stair was moved approximately 3 feet toward the east sometime during the 19th or early 20th century. If the adjacent bathroom was not constructed within the footprint of an earlier room the north wall of this chamber is contemporary with the bathroom. Surviving elements contemporary with the original construction of the building include:

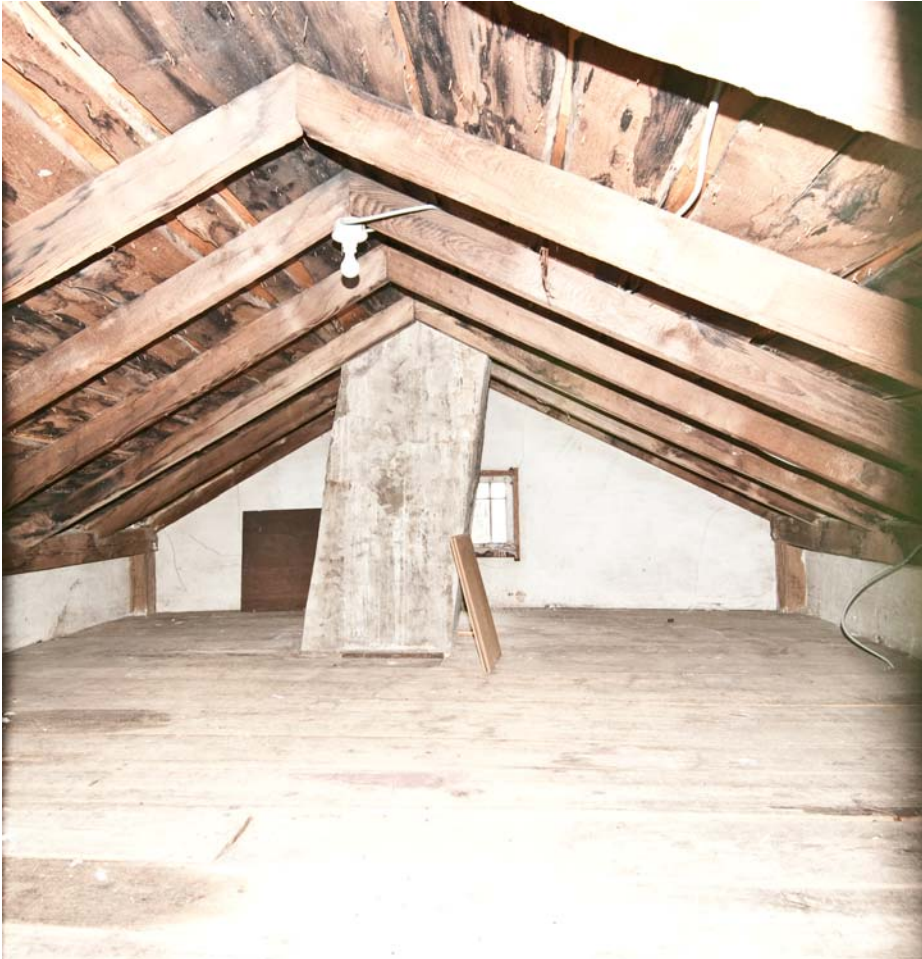
**Kitchen wing garret, looking south**

The garret of the kitchen wing is almost completely intact. Surviving 19th-century plasters on its walls indicate this space was used for some type of produce storage or possibly as lodging for farm workers.

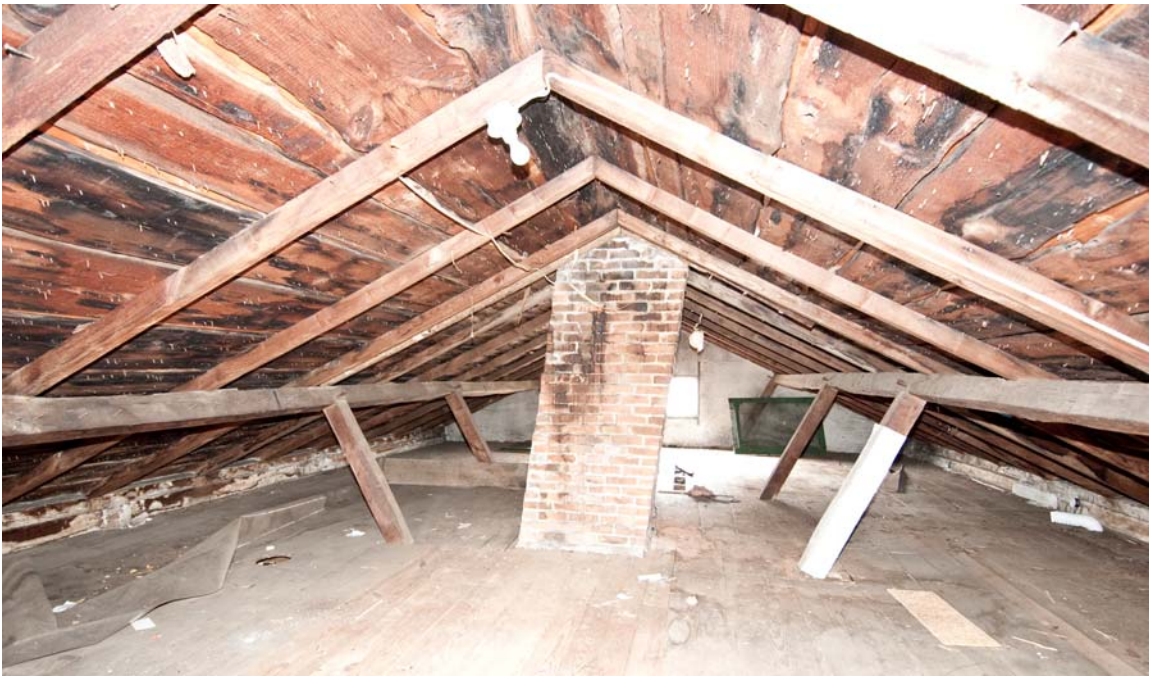
**Garret, main block, looking north**

The garret is mostly unaltered, the original framing is visible, much of the chimney also appears to be original. Sections of the flooring have been replaced possibly because of decay or to facilitate the installation of insulation or wiring.
